Sustainability in practice

Real performance at Skelton Grange

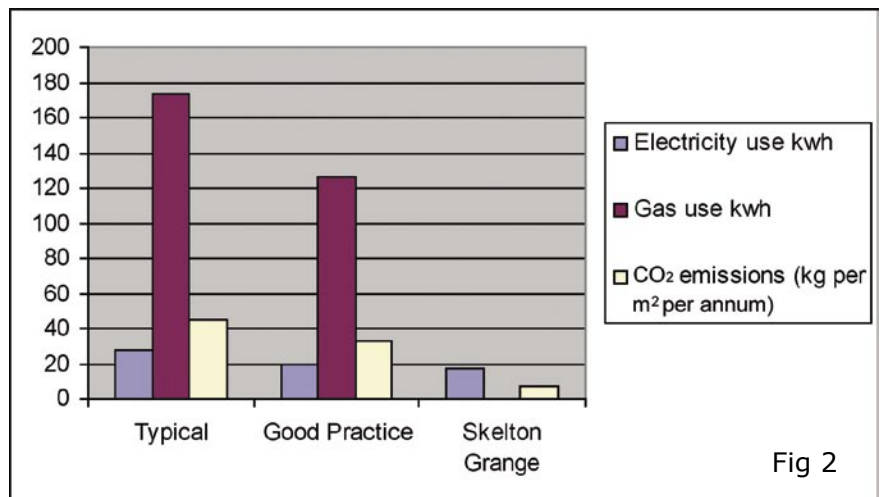
Fig 2

These figures show that Skelton Grange is producing 75% less carbon

Over the year to July 2006, Fig. 1 shows that the wind turbine and photovoltaic panels generated approximately 25% of total consumption (2195kWh of 7881 kWh consumed), the majority of this coming from the photovoltaics. The comparison of monitored energy used in the centre with good practice figures for primary schools (considered the closest building type for comparison) are encouraging and can be seen more clearly in the Table 1 and Fig. 2.
